LINCOLN ARCHAEOLOGICAL STUDIES No. 4

The Archaeology of the Lower City and Adjacent Suburbs

Kate Steane

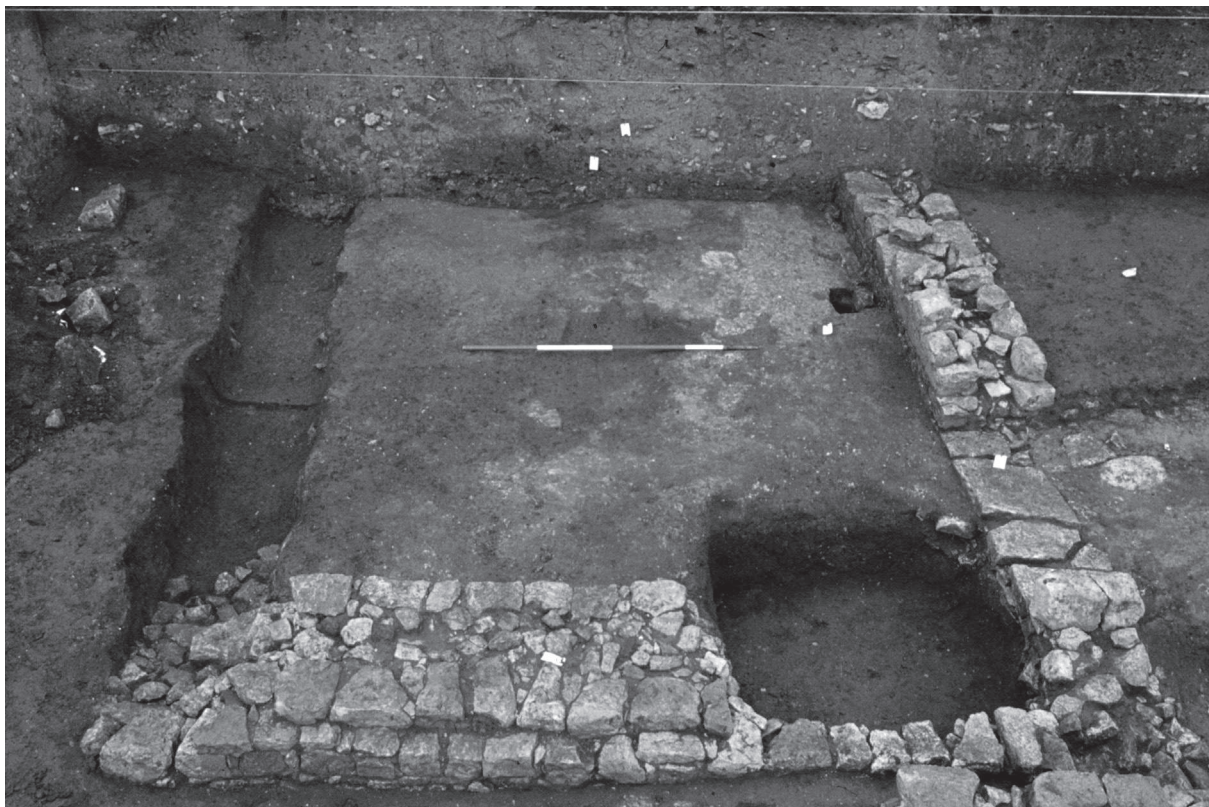
Fig. 14.62. Structure 4, looking north at wall cg33 and showing doorway (right): Trench I, LUB 107.

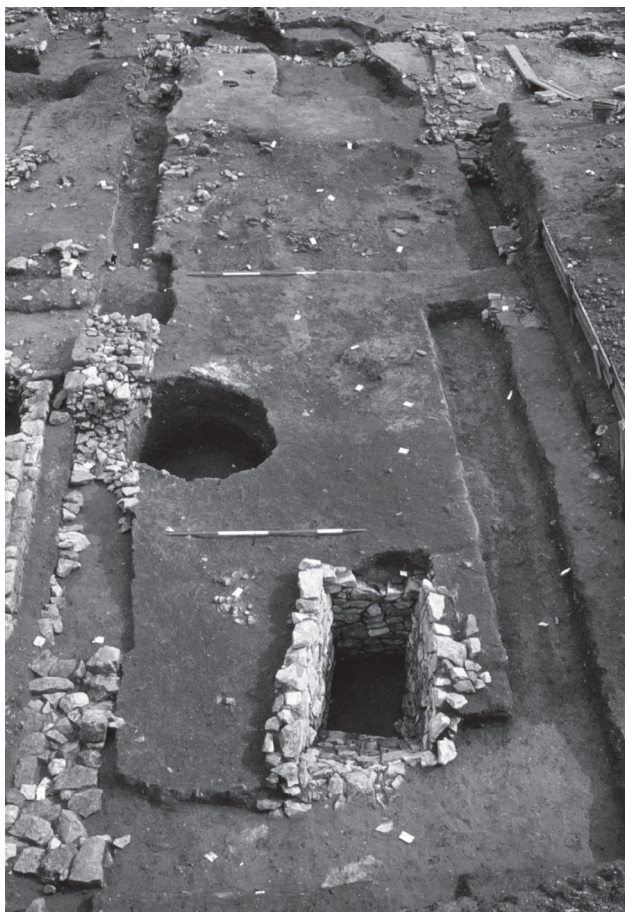
Fig. 14.63 (left). Structure 2B, looking east, with garderobe cg65 in the foreground: Trench I, LUB 109.

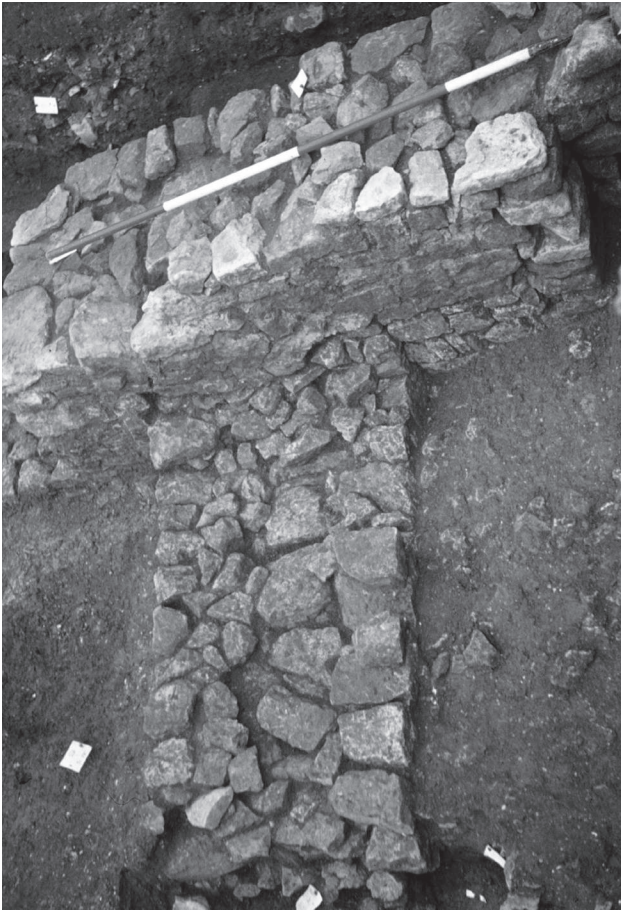
Fig. 14.64. The stone foundations cg52 of Structure 3 being partly reused and extended westwards for north wall cg54 of Structure 5: Trench I, LUB 120. Looking north.

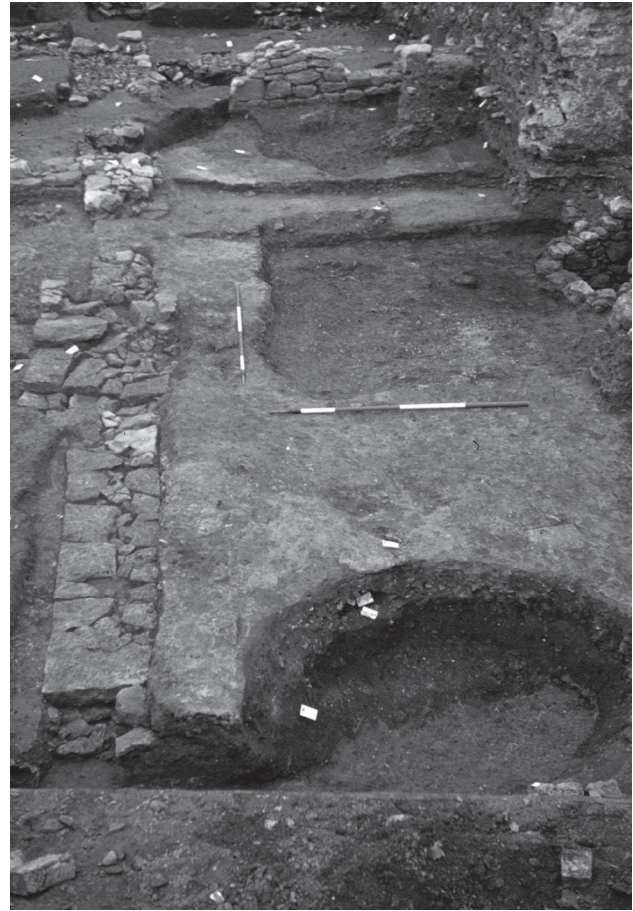
Fig. 14.65. Structure 5, looking north, with west wall cg17/22 to left, corner of garderobe cg67 to right, and internal east-west wall cg88 beyond: Trench I, LUB 120.

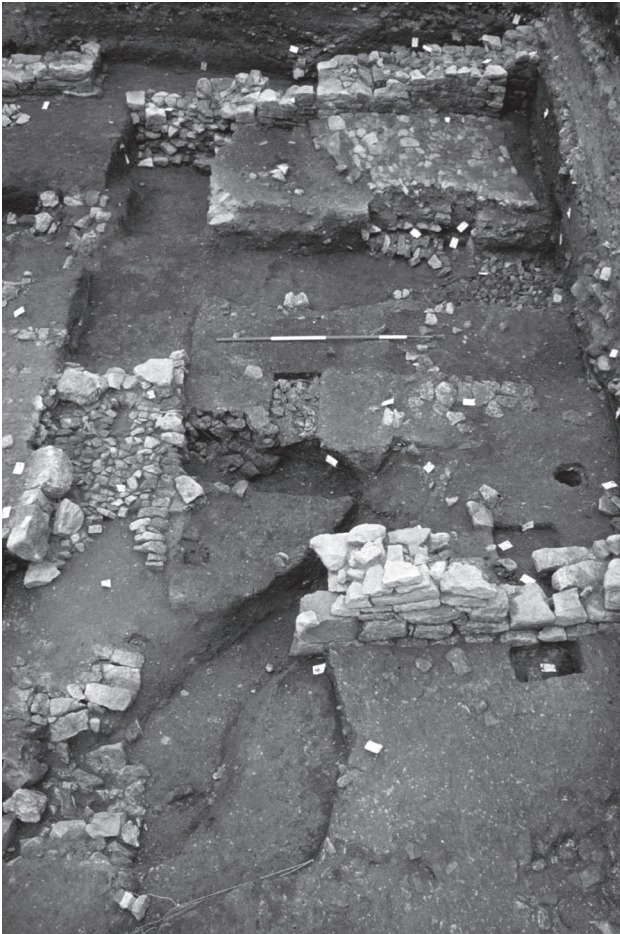
Fig. 14.66 (left). The northern part of Structure 5, looking north at internal wall cg88 (cut by flue of kiln cg123), and north wall cg54 beyond (cf Figs 14.64, 14.78): Trench I, LUBs 120 and 125.

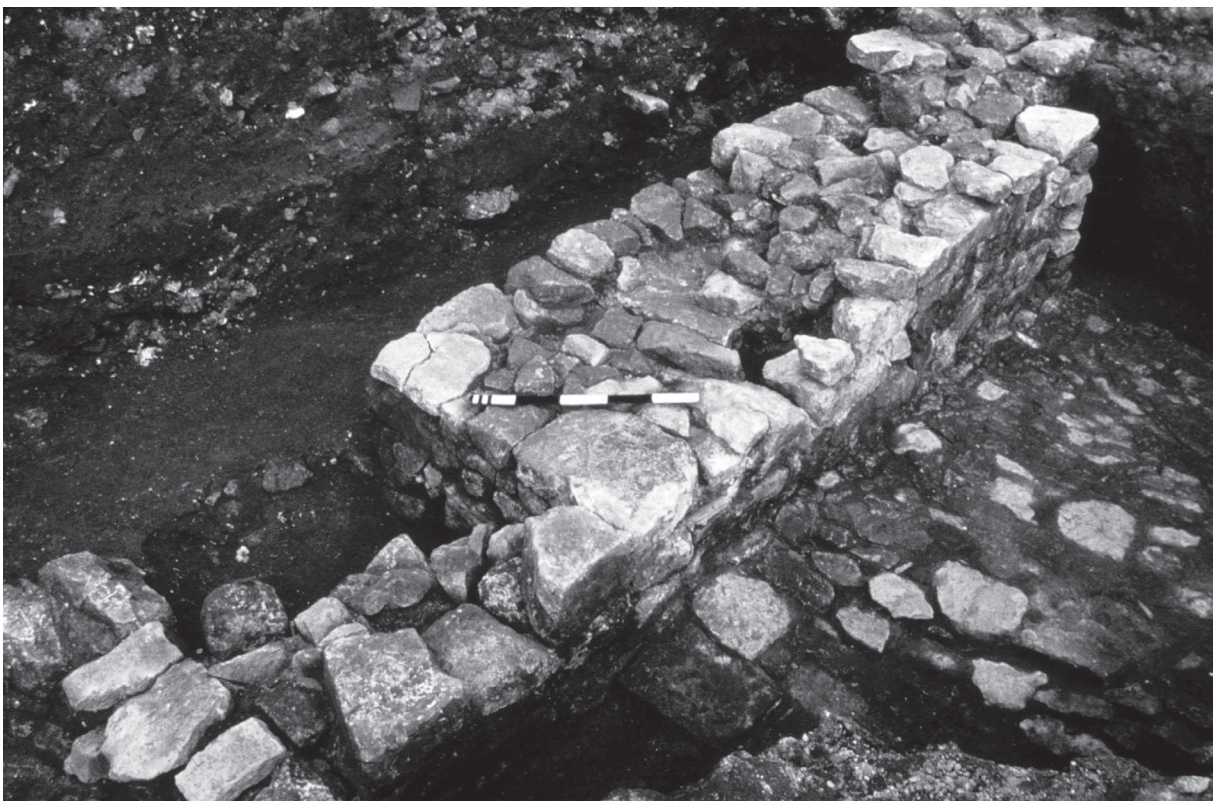
Fig. 14.67. Structure 5, room D, looking north-east at north wall cg54 and adjacent cobbling cg83. Also shown is doorway blocking cg149 (cf Figs 14.64, 14.66): Trench I, LUB 125.

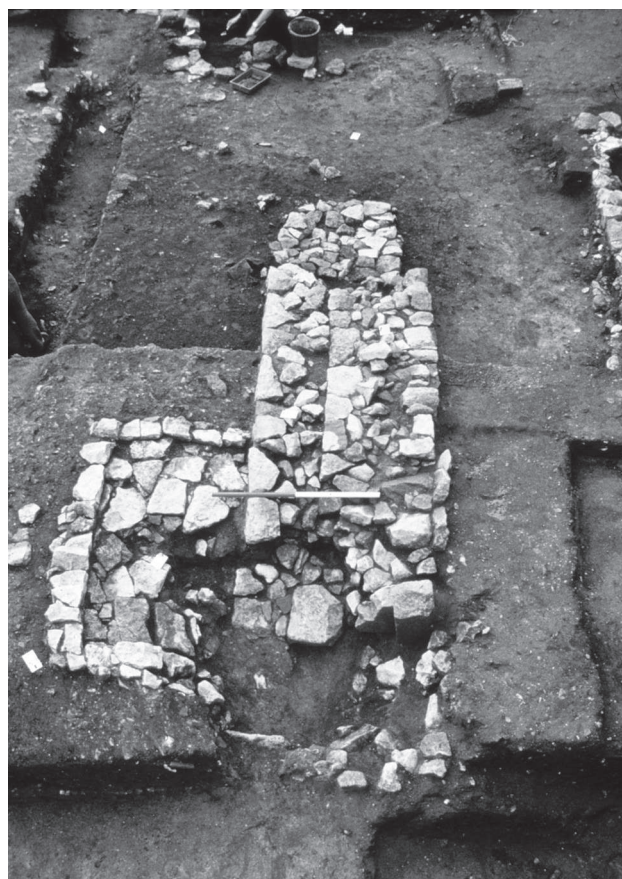
Fig. 14.69 (right). Structure 6, north side; looking west at wall foundations cg93 with adjacent remains of industrial(?) or storage feature cg509 on their south side: Trench I, LUB 126.

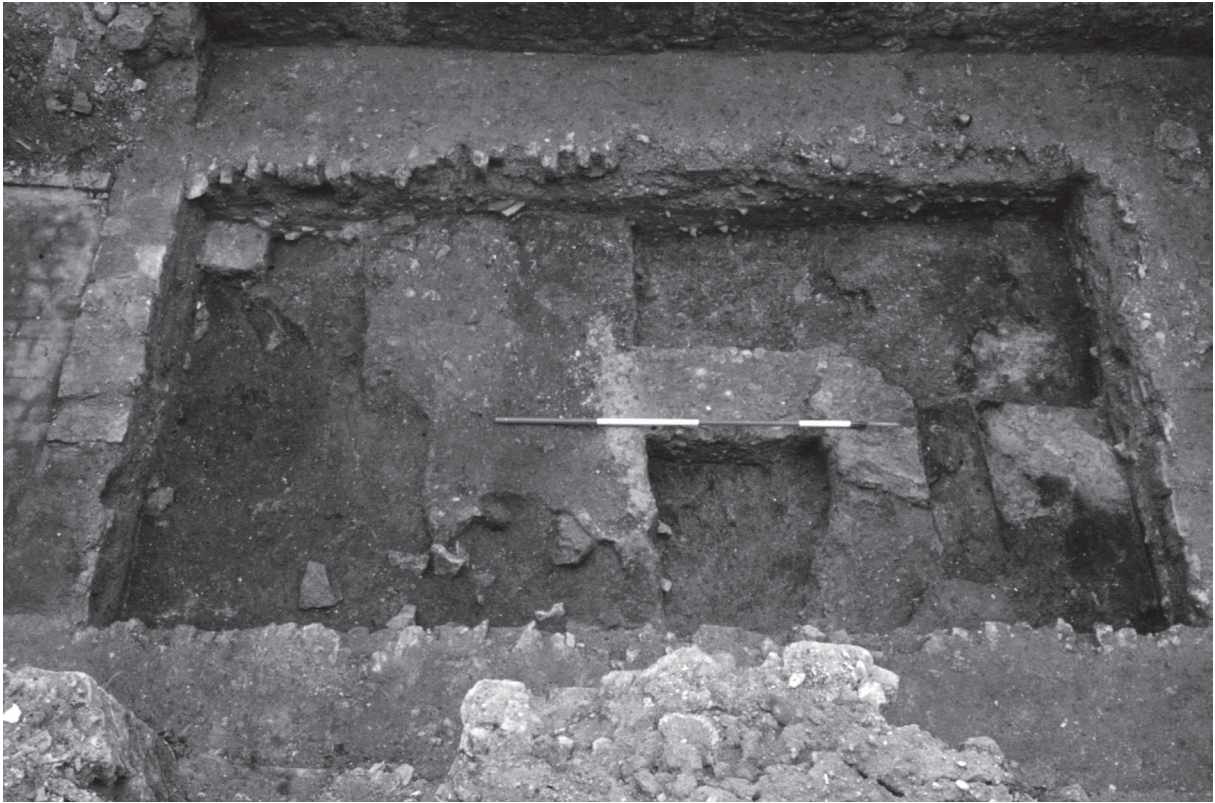
Fig. 14.70. The slight remains of Structure 46 indicated by fragment of clay floor, including burnt area cg358 (right), and of Structure 40 evidenced by robber trench cg366 (centre), with narrow strip of floor cg363 immediately to its left: Trench IX, LUBs 901, 903, and 904. Looking east.

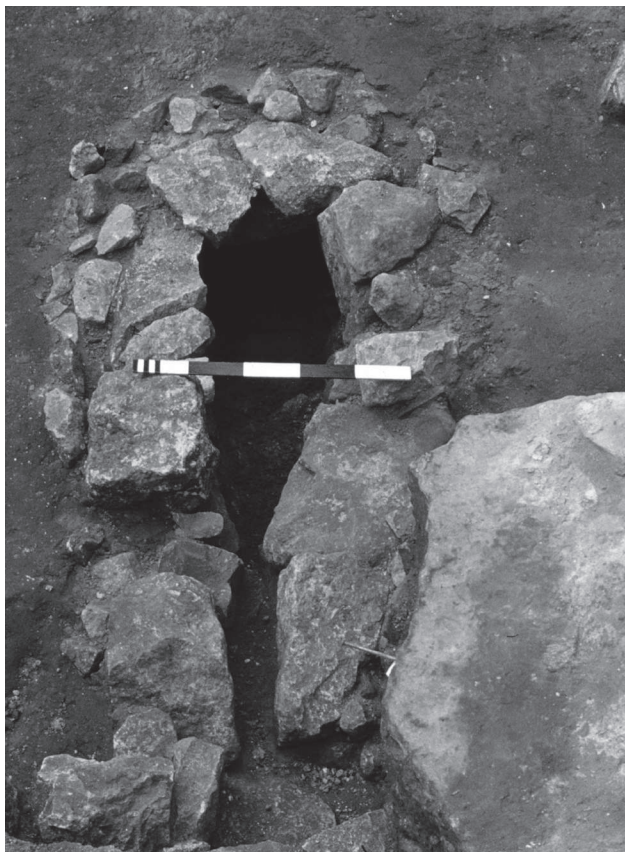
Fig. 14.72. Stone-lined pit cg267: Trench V, LUB 535. Looking west.

Cutting pit cg237 (LUB 522) against the eastern section in the northern part of the trench was a stone-lined pit cg267 (Figs 14.61, 14.72); it measured 1.15m north-south by at least 1.9m east-west, but its depth was not recorded. Its function was not clear: it may have been a garderobe pit or perhaps a soakaway, or possibly had an industrial purpose. It contained a small quantity (14 post-Roman sherds) of 10th- and 11th-century pottery, probably residual from its construction trench having cut through earlier deposits.

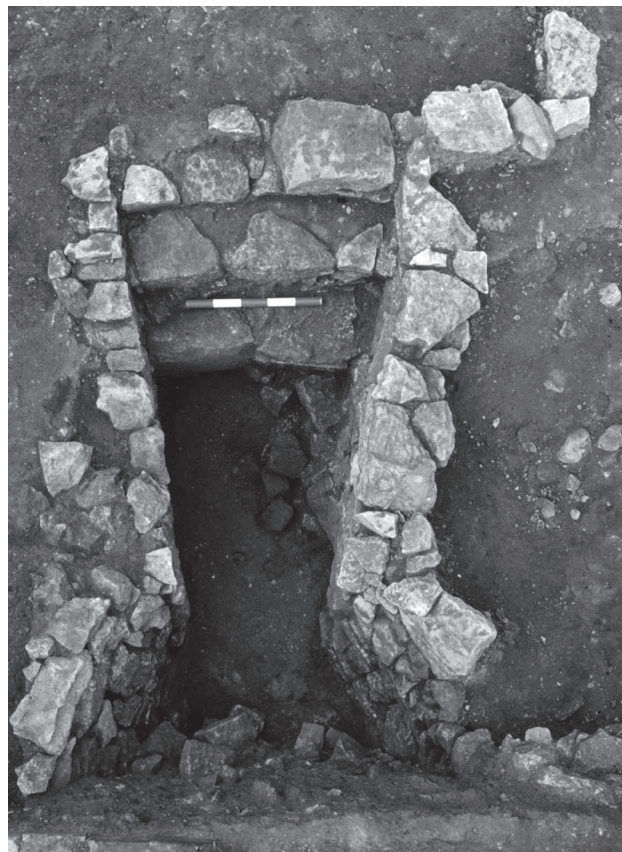
Fig. 14.73. Oven cg283: Trench V, LUB 541. Looking north.

Against the southern section of the trench, part of a keyhole-shaped stone-lined oven cg283 (Fig. 14.73) extended at least 2m into the trench. Its form was similar to those used for malting purposes. While there is no record of which deposits were cut by this feature, it seems likely that it cut dump cg242 (LUB533). There were three steps from the north going down into the oven; the sides of both the entrance and the chamber were lined with rough limestone blocks. It is possible that it was associated with Structure 24 (LUB539; see also LUB 547). There was no dating evidence.

A late medieval or early post-medieval keyhole-shaped oven (LUB 541; Fig. 14.73) was discovered in Trench V; its backfill (LUB 542) contained 15th- to 16th-century pottery. Such structures are regularly encountered on sites of this period, and were usually (but not exclusively) used for malting purposes, when the industry became a common urban domestic

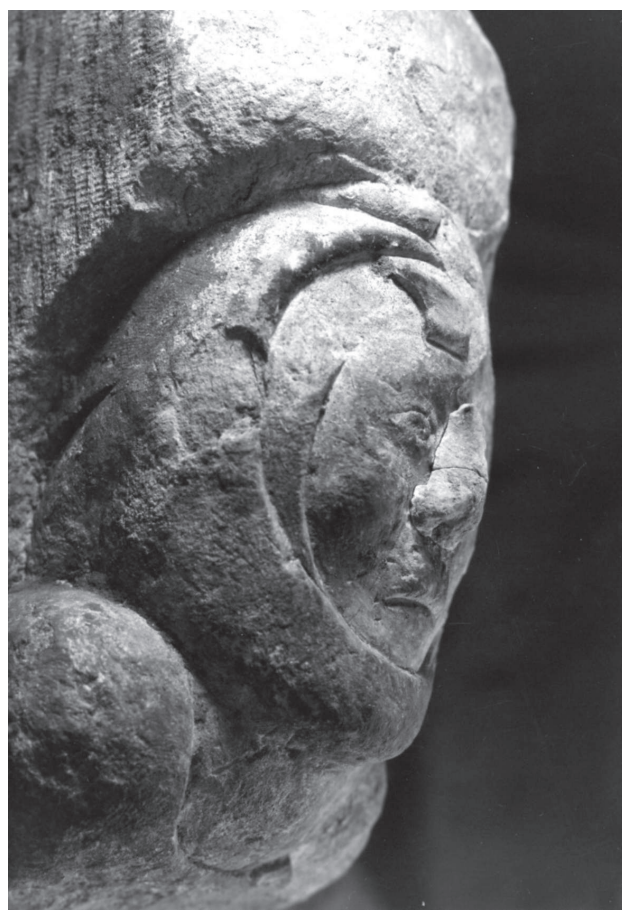
Fig. 14.76 (right). Stone corbel found in dump associated with lime kilns (Trench I, LUB 137).

Large groups of pottery were recovered from cg139, cg140 and cg145 (199 post-Roman sherds in total). The latest pottery dated to the mid 18th century; however, most of the material was of 16th- and 17th-century date. Fragments of 19th-century vessel glass were intrusive (possibly from the later building) in cg140 and cg145. From within dump cg139 was a large corbel block (I DN) <M20> supported by an almost life-size, bust-length, possibly armoured figure (Fig. 14.76). This is suggested to date from the mid 14th century (Stocker *nd*; see pp. 462–3).

An impressive 14th-century corbel (I DN) <M20> found in a dump associated with the lime kilns (cg139 LUB 137) was probably brought here as raw material for lime-burning (Stocker *nd*). The figure was apparently dressed in armour (Fig. 14.76). Its size indicates that it had originally formed part of a large composition, and it may have been brought to the site from the demolition debris of a large building, ecclesiastical, public or even private. One possibility is the Clasketgate itself, which was ornamented with a range of large heads (as shown in a sketch by Buck: Stocker (ed) 2003, 183–4); it was demolished c 1780. Alternatively, the corbel could have come from the Dominican friary on the north side of Monks Road, from a fine domestic building, or from a nearby church, perhaps one of those damaged in the Civil War such as St Swithin.

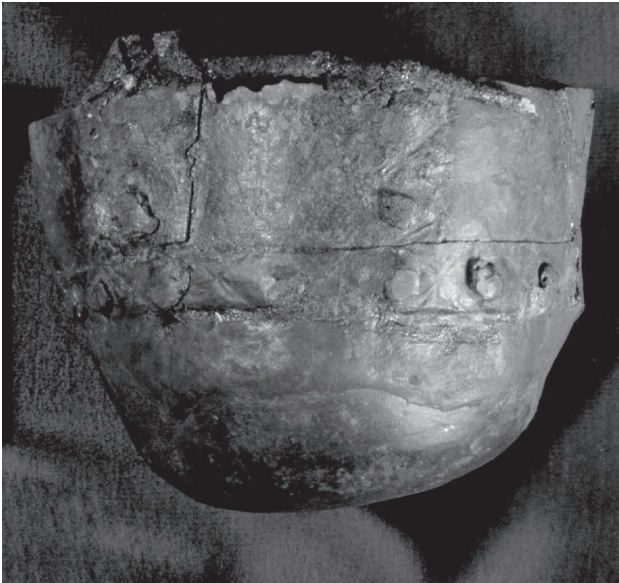
Fig. 14.77. Distorted copper alloy kettle from backfill of lime kiln (Trench I, LUB 138). H: c 90mm

been beaten out of thin sheet, while the upper part was patched with at least two separate, overlapping strips, secured by sheet copper alloy rivets (Fig. 14.77). Two sheets of copper alloy folded double over the rim of the vessel on opposing sides were secured by sheet copper alloy rivets; within one of these a small perforation housed the terminal of the remains of an iron rod handle. This originally was almost certainly similar in form to a brass kettle with iron handle found in Rotterdam (*cf* Ruempol and van Dongen 1991, 177, F4948); such vessels frequently appear in prints of the 16th and 17th centuries. The form of the rivets used suggests that it had been repaired in the 17th century.

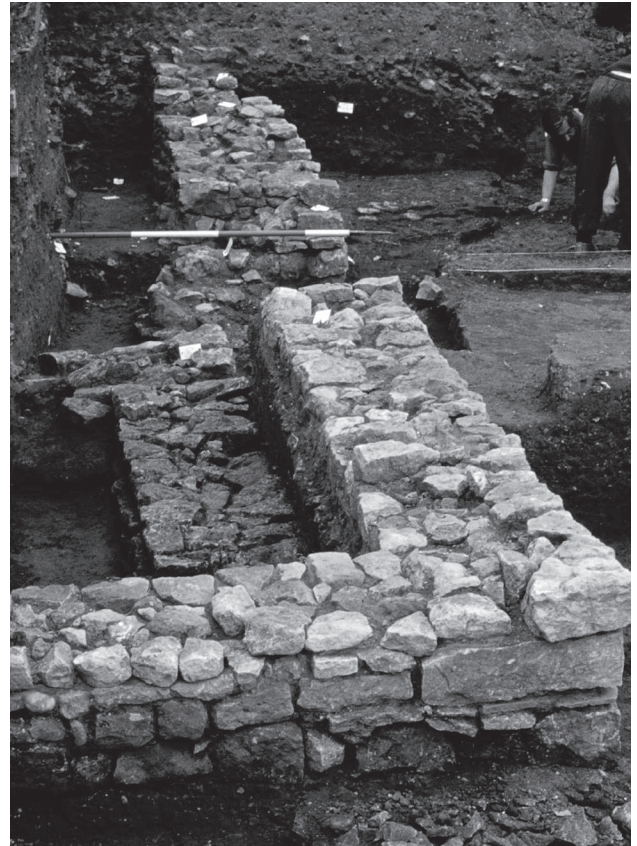
Fig. 14.78. Structure 9, looking east at wall cg150, with north wall cg54 of Structure 5 beyond; the foundations of wall cg29 (Structure 8) are visible parallel to and immediately to the left of wall cg150: Trench I, LUBs 121 and 140.

Against the north section, an east-west stone wall cg150 (at least 4.3m long and 0.6m wide; Figs 14.78 and 14.79) cut cobbles cg163 (LUB 133) and dump cg147 (LUB 136), and sealed one of the postholes cg24 (LUB 131). The eastern part of this wall had been truncated by later building, but there was a return to the north (at least 2m long) at its west end. It probably represented the south-west corner of a building, Structure 9, which may have been associated with the lime workings (LUB 137). All pottery was residual (six sherds of Saxo-Norman to late medieval date) but this LUB post-dated the early-mid 18th-century LUB 136.

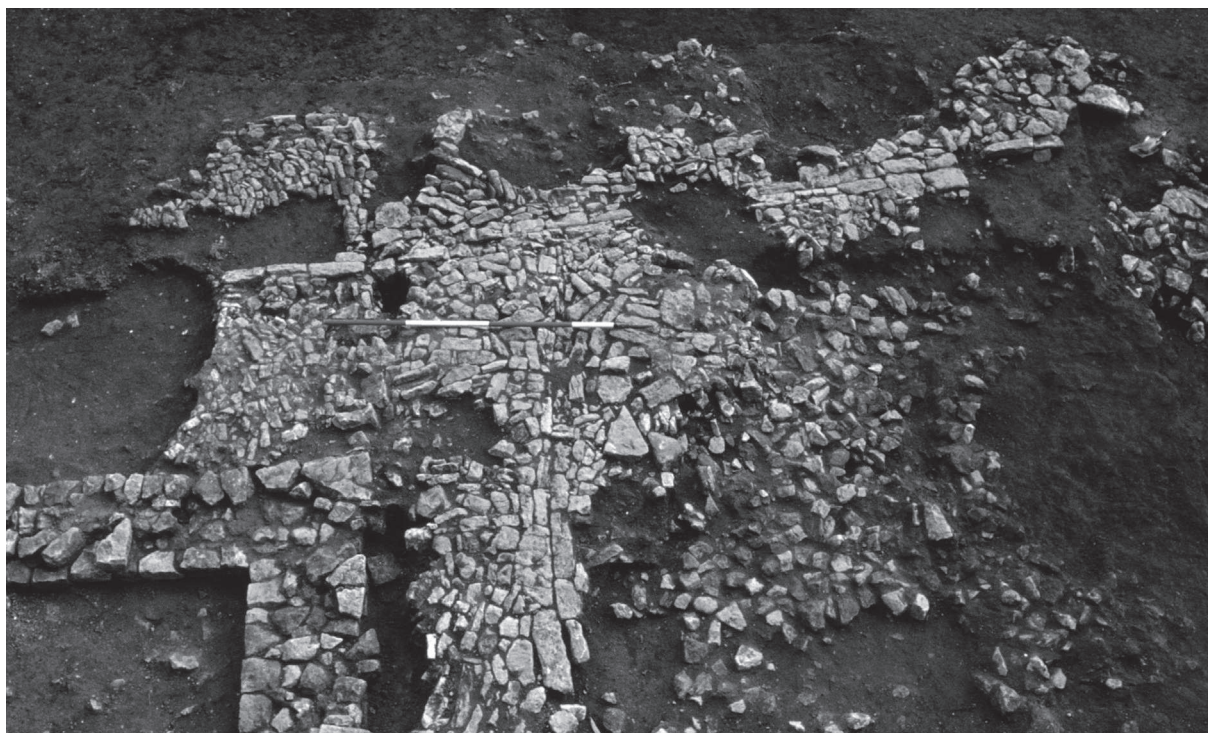
Fig. 14.79. Structure 9, looking south at corner of wall cg150 cutting earlier cobbling cg163: Trench I: LUBs 133 and 140.

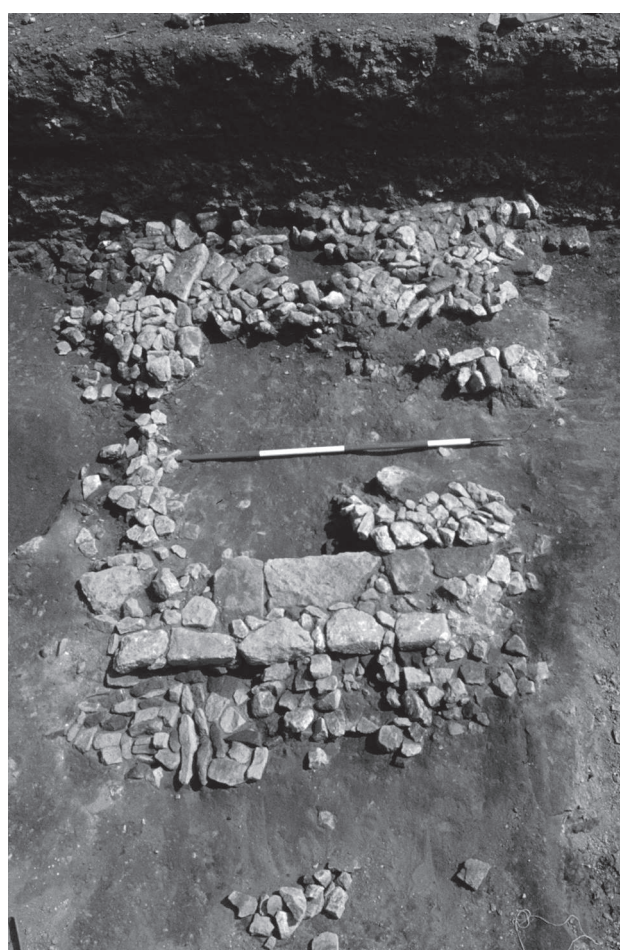
Fig. 14.80 (right). Looking east at cobbled surface cg146, associated with north-south wall cg144: Trench I, LUB 141.

A deposit of dark greyish loam with grit and mortar, partly sealing dump cg139 (LUB 137), formed the make-up into which a cobbled surface cg146 was set. This surface, extending at least 3.2m north-south and *c* 5m east-west, appeared to be sealed by a north-south wall cg144 (Fig. 14.80). The wall was 0.6m wide and was only traceable for 1.9m.

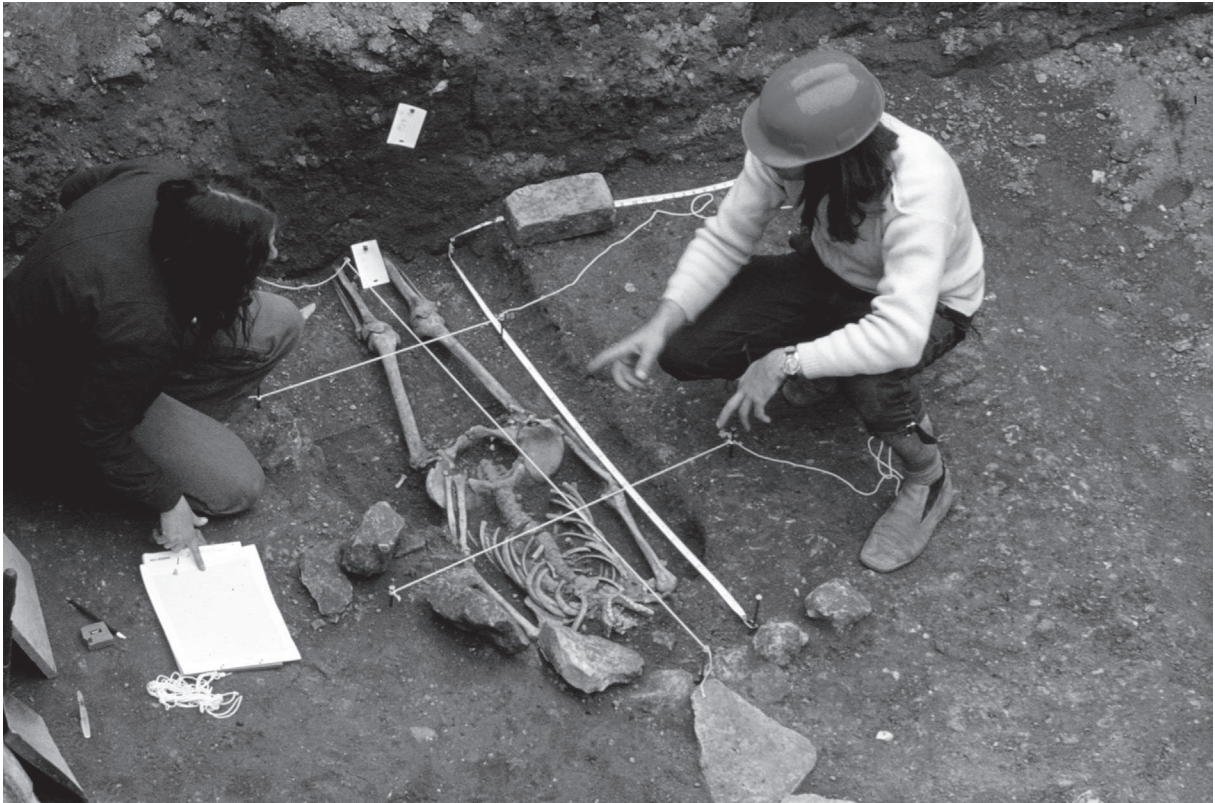
Fig. 14.81. Recording of the burial cg355 in progress: Trench VI, LUB 616.

Cutting cg353 (LUB 615) was a grave cg355 (at least 1.62m long and 0.62m wide), aligned east–west. The skeleton was that of a young/middle-aged female (Boylston and Roberts 1995a); the feet and ankles lay outside the area of excavation and the skull seemed to be missing (Fig. 14.81). There appeared to be stones around the head of the burial. The context of the grave here is considered below (p. 464). Both this and cg353 (LUB 615) were sealed by the modern cellar floor which, according to documentary, architectural and cartographic evidence, was probably built c 1852 (see further, p. 467).

Only one grave cg355 (LUB 616; Fig. 14.81) was actually found *in situ* within the area of the excavation, and it was not apparently within a graveyard. Others may have been previously recorded nearby: an account in the *Lincolnshire Chronicle* for 16 July 1852 notes the discovery, at the corner of Unity Square, of 'a quantity of human bones, and ...a stone coffin, in which a perfect skeleton laid' [*sic*]. The coffin

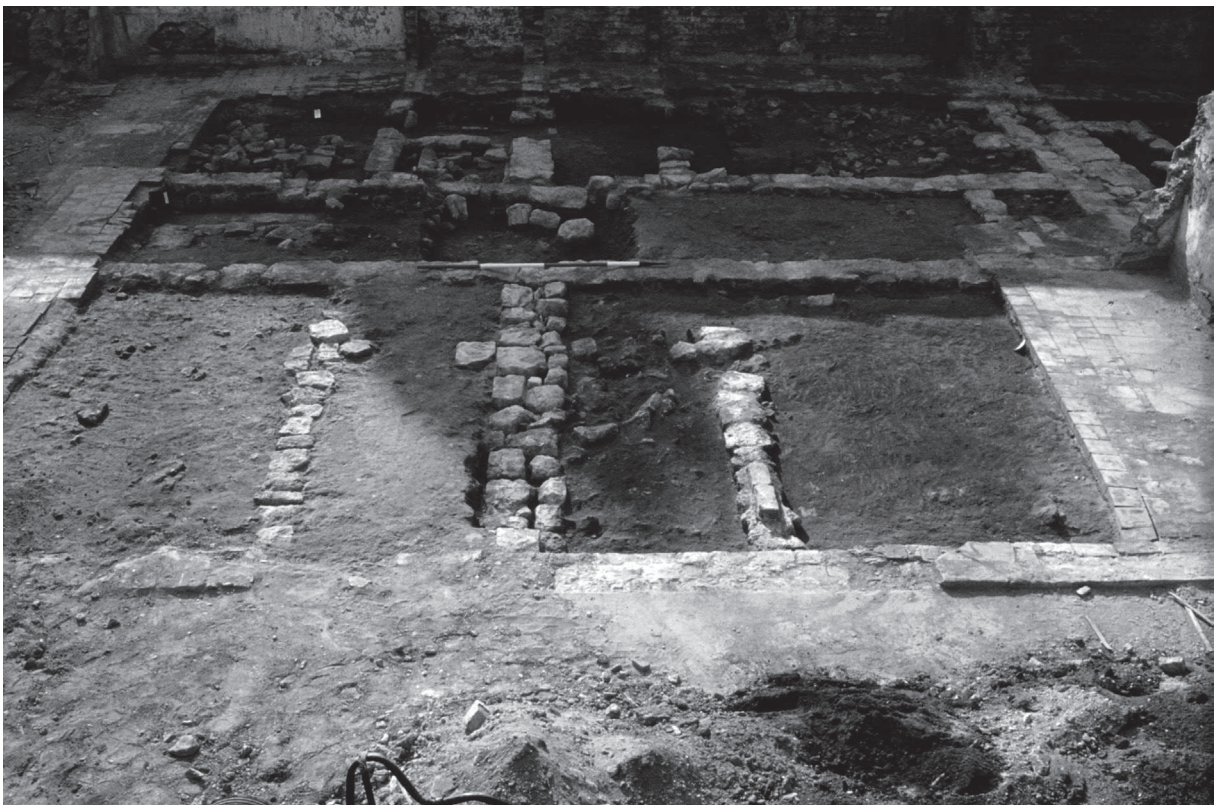
Fig. 14.82. Structure 28; looking west at foundations of the cellar walls cg289 and, beyond, cg310: Trench V, LUB 549.

cg519 (LUB 548) of Structure 27 were reused in this building; a new east-west wall cg526, c 0.38m wide, appears to have been built against the south face of wall cg275. The walls had stone foundations and brick superstructures (Fig. 14.82). There was a central north-south corridor (about 1.5m wide) with at least four rooms on either side; each room was of a different north-south dimension, and all had tiled floors.

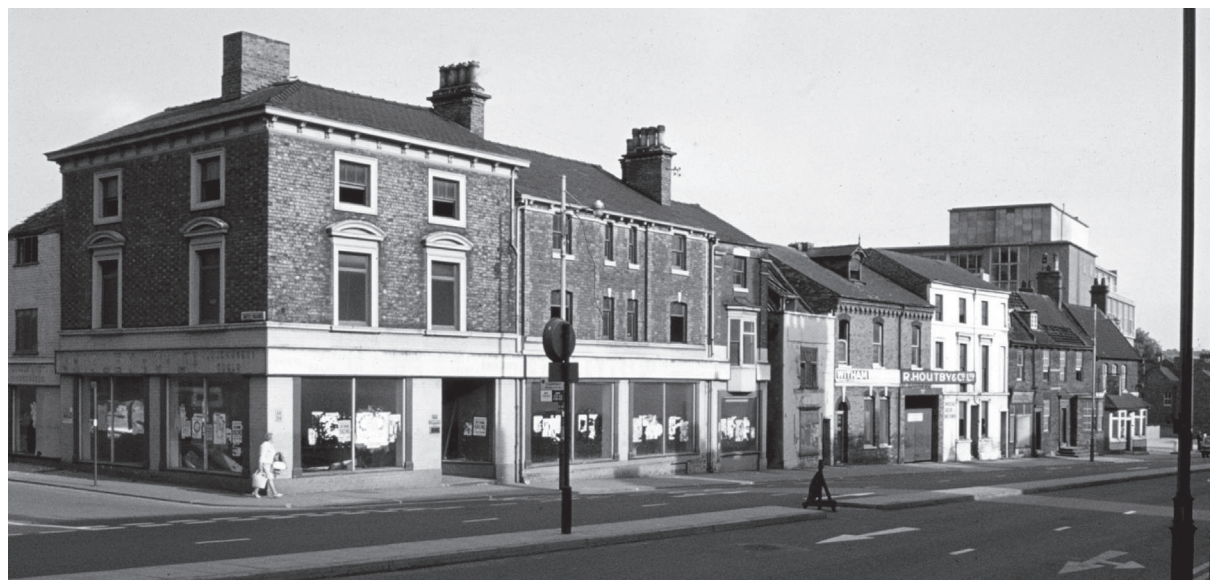
Fig. 14.83. Nos 22–23 Broadgate (at the corner of Unity Square) and 20–21 Broadgate, and adjacent buildings to the south, shortly before demolition in 1973. Looking south-east.

Sealing layer cg361 (LUB 903) was a compact layer of 'mortary material', rubble and a piece of concrete cg362. Over this and sealing clay cg363 (LUB 903) was a layer of soil cg364. The whole area was then covered by a layer containing mortar fragments cg368, which sealed robber trench cg366 (LUB 904) and pit cg367 (LUB 905). It was probably levelling in preparation for the construction of a cellar. Small mixed groups of 10th- to 19th-century pottery were found in cg364 (54 post-Roman sherds) and cg368 (17 post-Roman sherds). Photographs of the site in 1973 prior to demolition show a three-storey building here dating to c 1800 (see Fig. 14.83).

The cellars that formed the locations for Trenches IX and X belonged to houses that were of a style current *c* 1800, the earliest to survive until the demolitions of 1973 (Fig. 14.83). Cartographic evidence indicates that those on the site of Trench I were erected at a date between 1851 and 1868. The cellar of Trench II lay towards the rear of the house numbered no. 17 Broadgate. Although its site had been occupied previously, this building had been demolished and the land was vacant on Padley's 1883 map (Mills and Wheeler (eds) 2004, 94). An application to the Corporation of Lincoln (as Urban Sanitary Authority), dated 2 March 1885, was made by the architect Michael Drury for a 'House and Leather work Factory' (Lincoln City Buildings Register no. 1676) that included the cellar.

The area covered by Trench V occupied part of nos. 22–23 (on the corner of Broadgate and Friars Lane) and, to their south, nos 20–21. Both survived until 1973 (Fig. 14.83): the former was the earlier, dating on architectural grounds to the 1820s–30s, while the house listed as nos 20–21 was probably built shortly before Padley produced his 1842 map. The shape of Trench V is explained by the fact that nos 22–23 (Structure 26; LUB 546) appear to have had a cellar covering only the front part of the house, while nos. 20–21's basement (Structure 28; LUB 549), and the yard allowing rear access to it, extended much further to the east. A building with a smaller cellar (Structure 27) pre-dated that which had survived. If it was built against Structure 26 to the north, as suggested by the excavators' site plans, it was comparatively short-lived and is otherwise not documented, but its north–south wall was reused in the next phase. This might explain the apparent relationship of this wall to the new north wall of 20–21 Broadgate: the cellar wall did not cut through the east–west wall, but the new walls stopped short of the existing cellar's junction with the south wall of no. 22/3 as it was being retained. Permission was granted in 1919 to Messrs Shipley and Co for

a new warehouse to the east of the corner property (described on the accompanying plans as a shop; Lincoln City Buildings Register no. 5511), and there were further additions in the following decades as Shipley's business grew and its showrooms were extended into the front part of nos. 20–21 (see Fig. 14.83). The new warehouse of 1919 was built immediately east of an existing warehouse along Unity Square. It was the cellar at the eastern end of this last-named structure, built *c* 1852, which was the location of Trench VI.

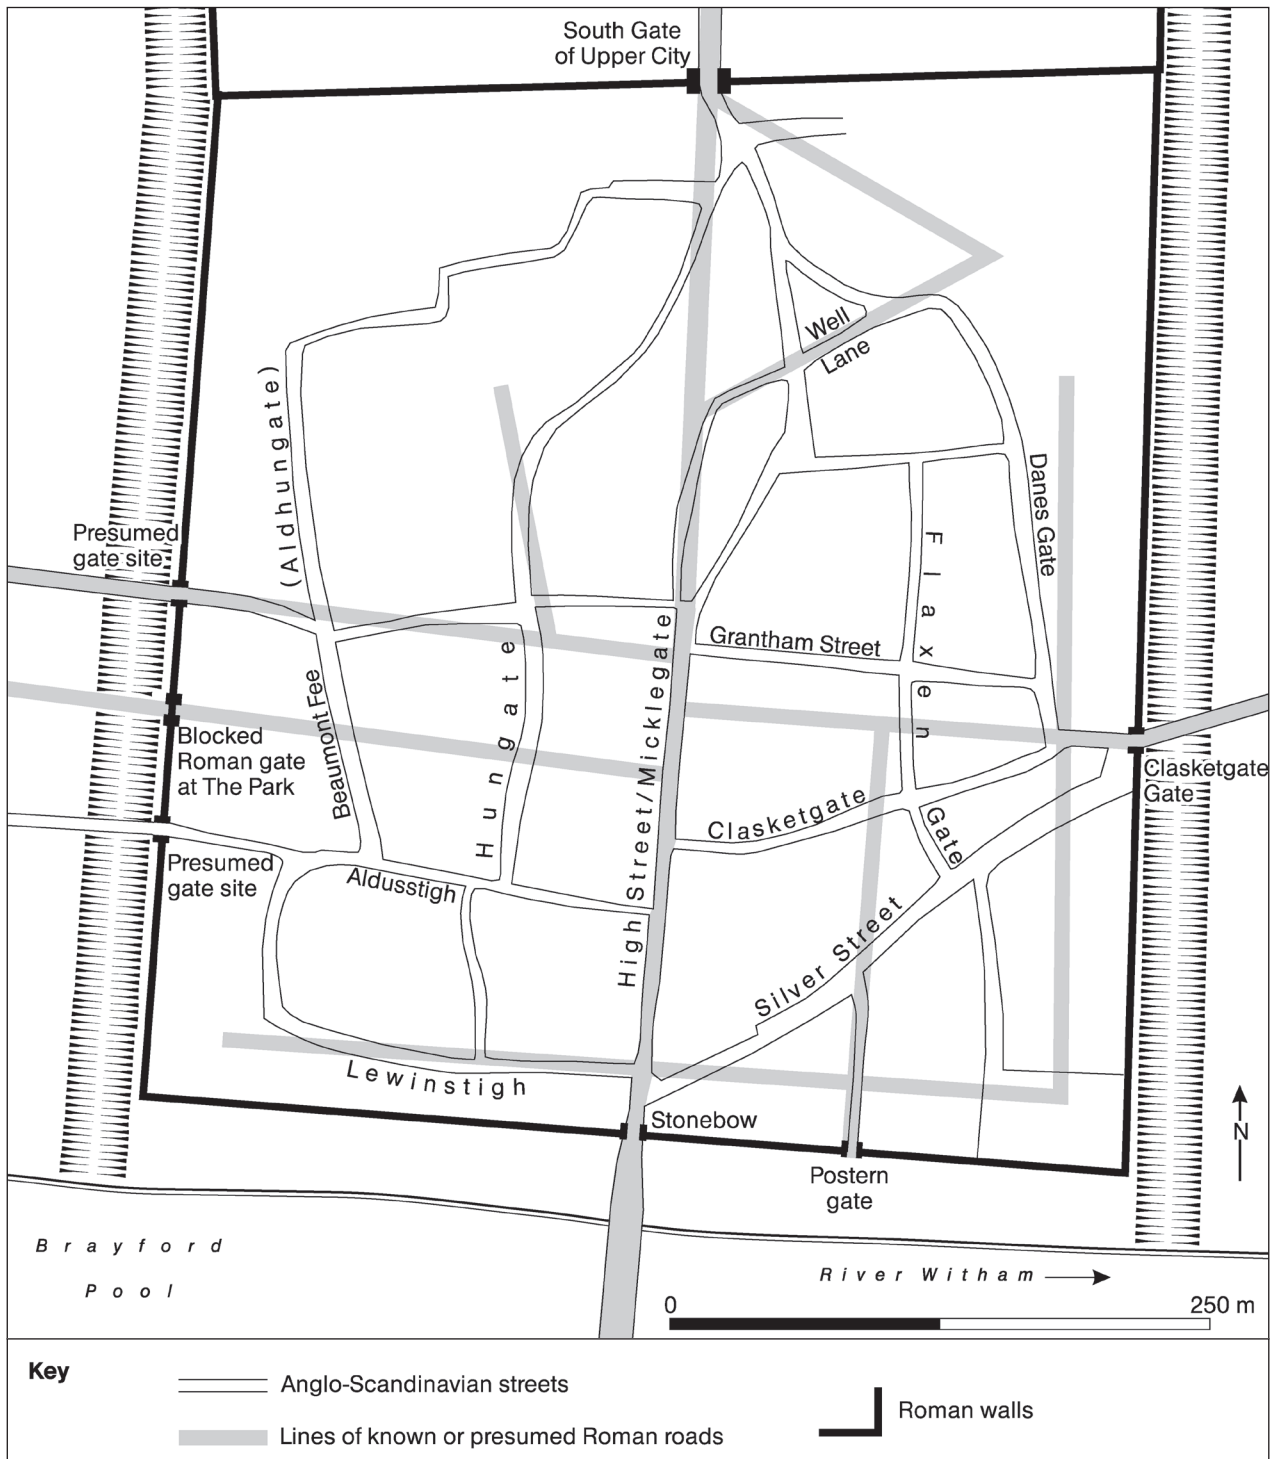
Fig. 15.8. Plan showing probable Anglo-Scandinavian street pattern within the Lower City in relation to that of the Roman period (D Watt; copyright English Heritage).

the orientation of the 10th-century pottery kiln at lin73si B, and of 10th-century buildings at lin73sa E, show that Silver Street, whose alignment cuts across the old Roman grid (Fig. 15.8), was in existence by this time. As noted above, it is possible that the
